An experimental Earth Observation-based screening layer — not a structural safety assessment

Nicholas Rasetta — ORSS, Independent Project, Italy | orss.it

Can publicly available Earth Observation and school-building records provide a scalable, transparent screening layer to help prioritise sites for further geological, geotechnical or structural investigation?

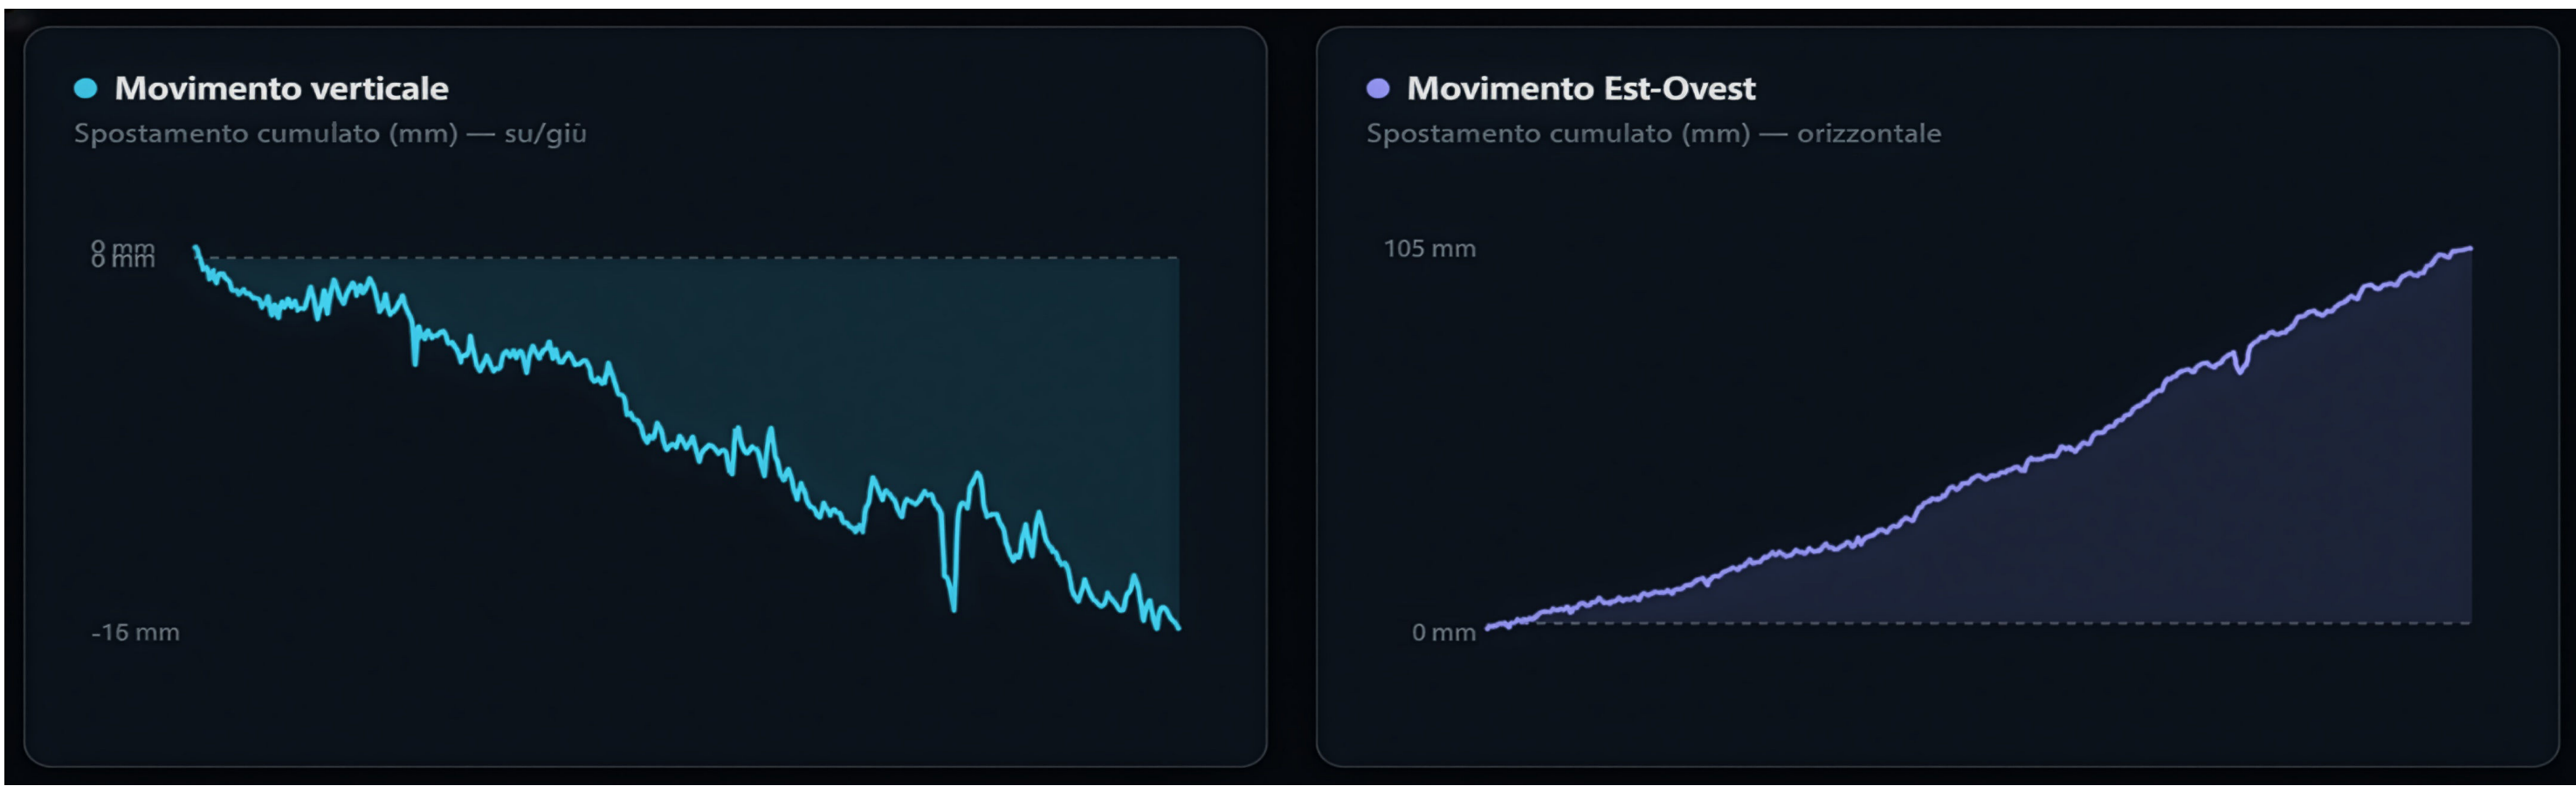
Fig. 2 — EGMS vertical (left) and East-West (right) ground-motion trends for measurement points associated with the Bucchianico school site and used in the ORSS screening analysis.

**Bucchianico - Via Santa Chiara**  
School building

ORSS score **32.97**

**Documented hydrogeological instability** (public record)
